# Geotechnical Report

## Scott Hill Park and Sports Complex

Woodland, Washington

Project No. 15012

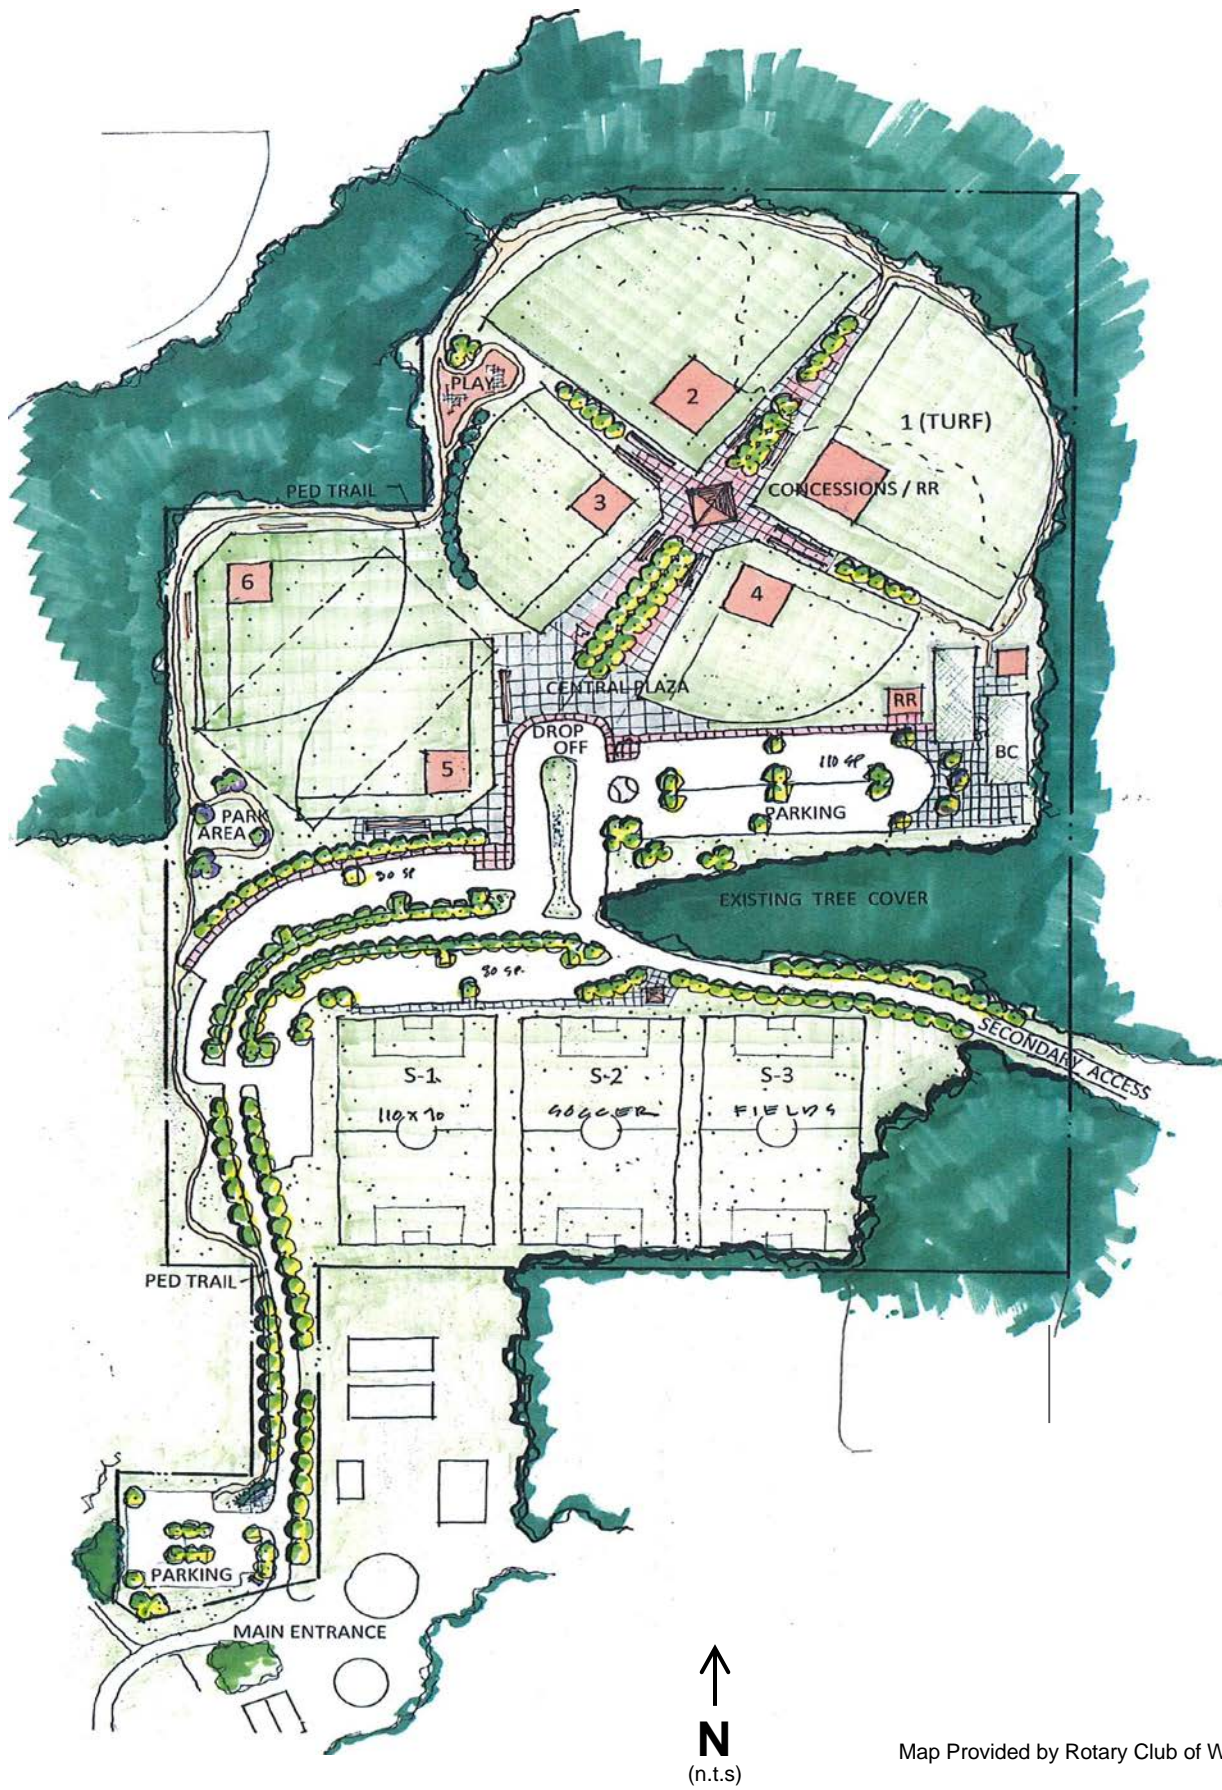
**FIGURE**  
2

**CONCEPTUAL PLAN**  
Scott Hill Park and Sports Complex  
Woodland, Washington
